REPORT  
ON  
THE FLOODS OF THE MOIRA RIVER,  
AT  
BELLEVILLE, ONT.

APRIL, 1920.

WALTER J. FRANCIS & COMPANY  
CONSULTING ENGINEERS  
MONTREAL.

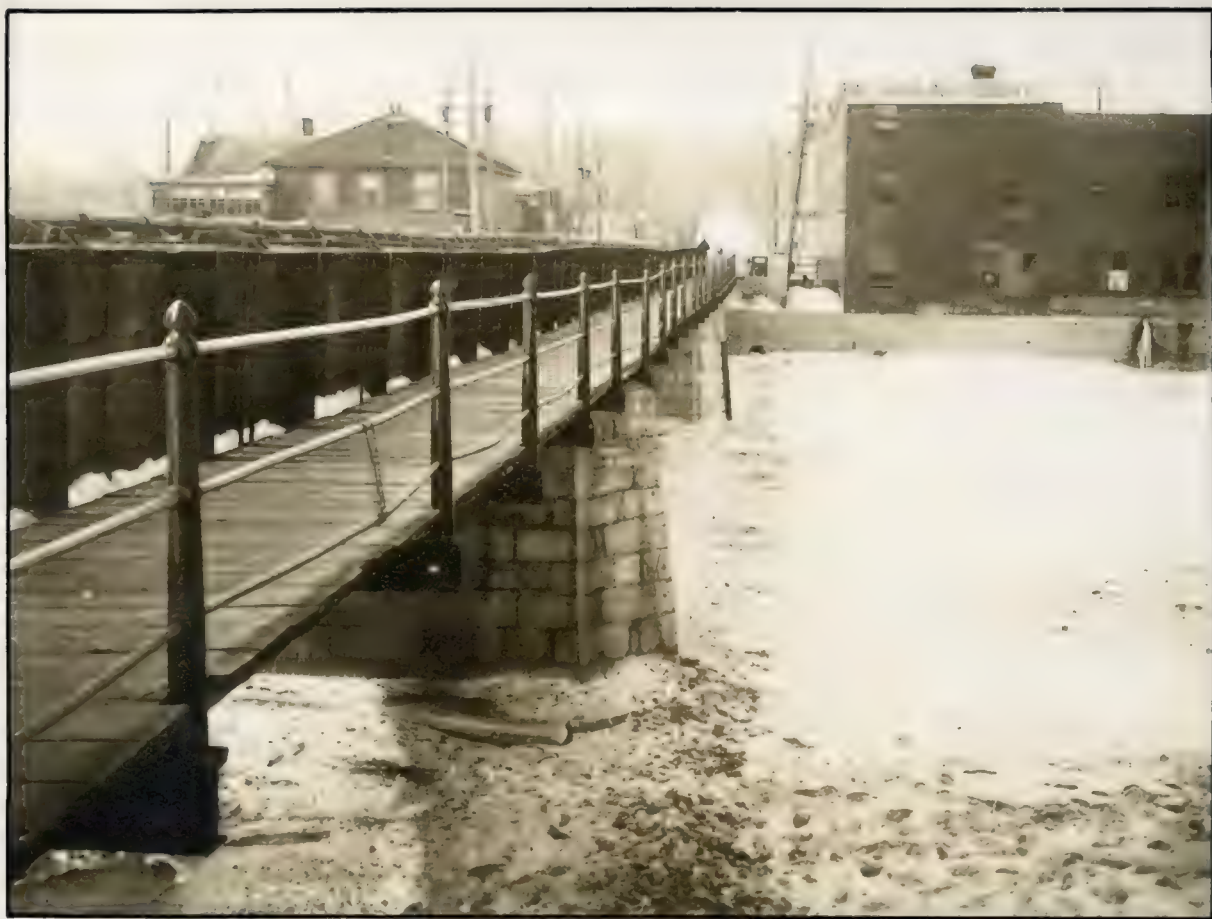
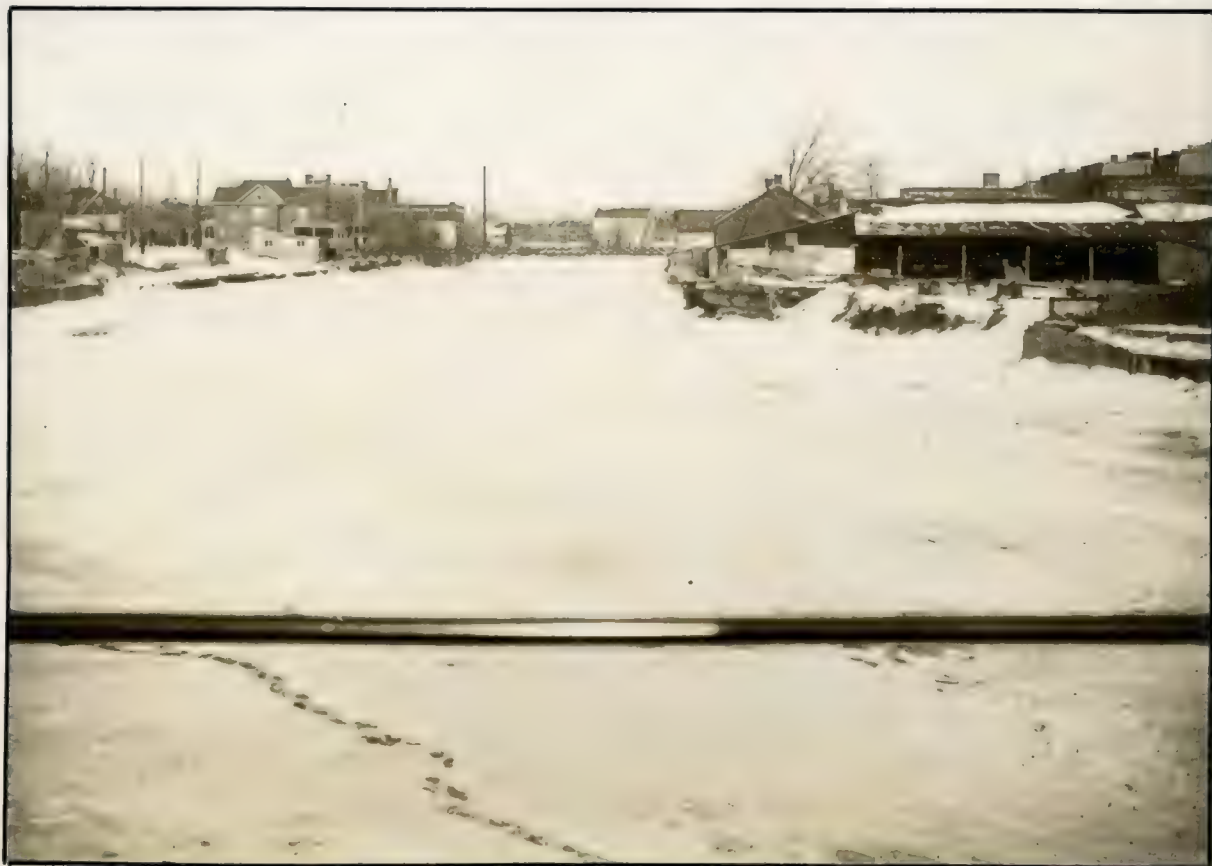
The Lower Bridge has three spans, 50 feet, 84 feet and 62 feet in the clear, with two masonry piers 6 feet wide. The clear waterway below the underside of the girders is 3,898 square feet. The upstream side is shown in photograph No. 1, while a view looking upstream from this bridge, with the Foot Bridge in the background, is shown in photograph No. 2, both on page 8.

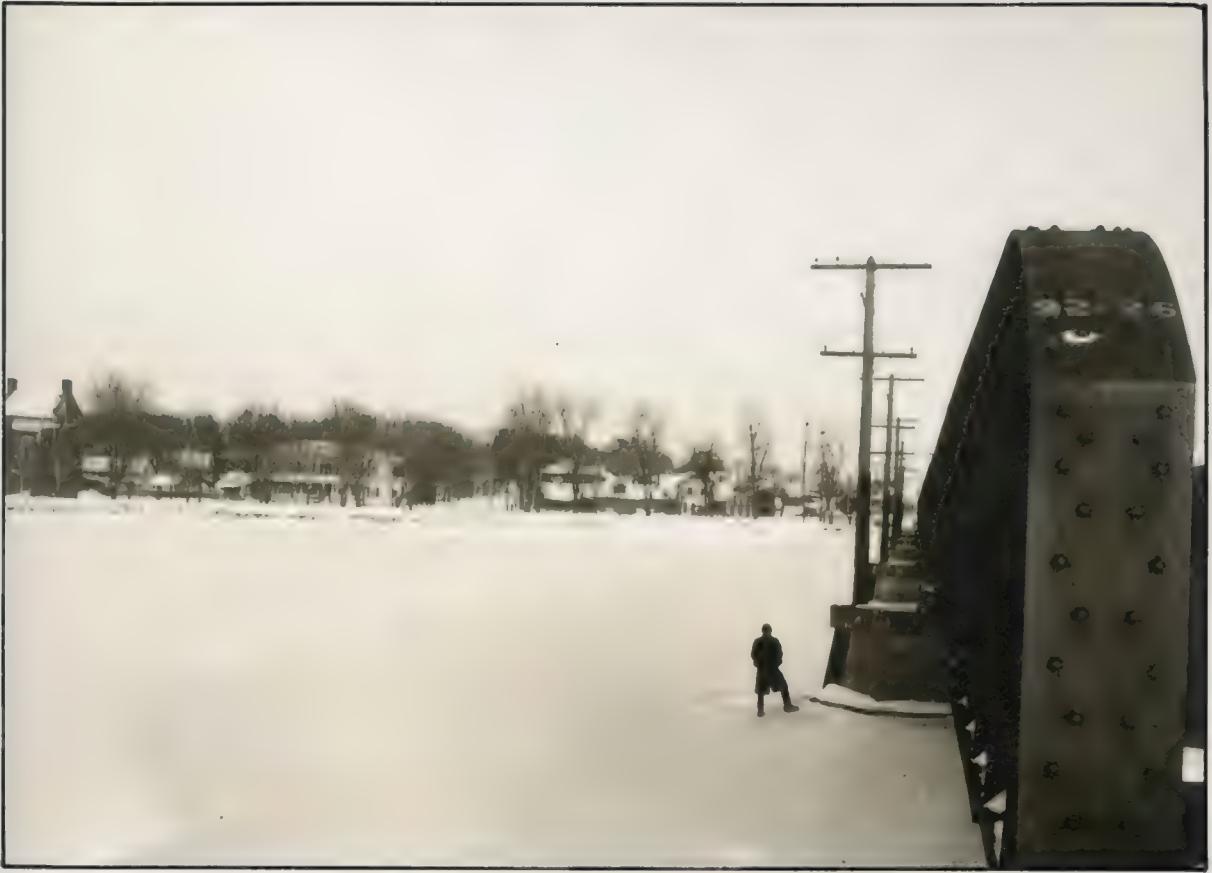
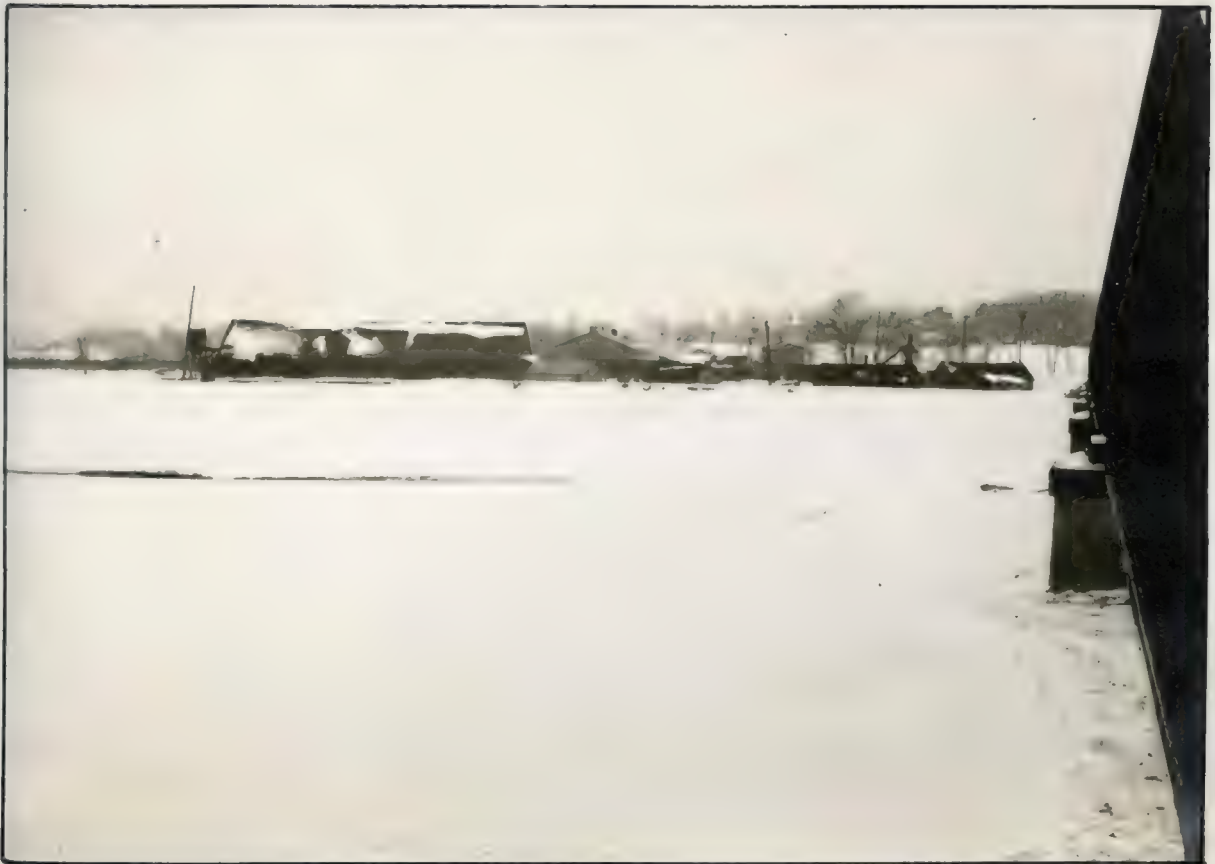
Photograph No. 5.

Photographs Nos. 3 and 4 included as page 10, show the upstream and downstream sides of the Railway Bridge in typical mid-winter conditions, while No. 5, included as page 11, shows the downstream side of the Railway Bridge looking upstream.

As previously stated, our examination of the conditions in the Moira River commenced during the third week in January, and was carried on continuously until after the flood had occurred. Owing to the very steady low temperature that continued uninterruptedly during the winter months, the Bay of Quinte and the Moira River throughout the City of Belleville were frozen over with ice of exceptionally great thickness. In various places between Cooper's Dam and the Lower Bridge there were narrow channels either entirely open or only lightly frozen over, and in the vicinity of the Railway Bridge an open channel extended almost continuously from about 300 feet north, past the second pier from the east end, thence southerly and westerly through the southerly culvert in the dyke leading to Victoria Park, part of which open channel can be seen in photographs Nos. 4 and 5. There was also an open channel along the west bank of the river.

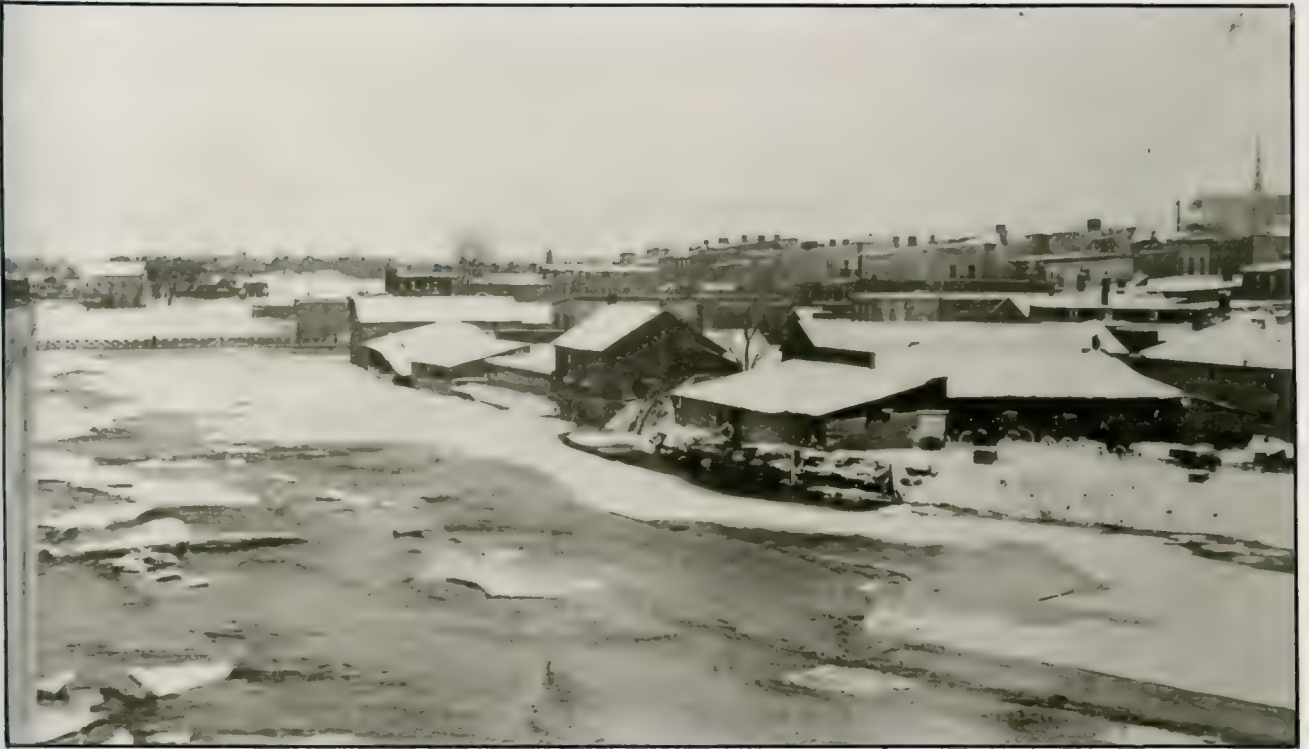
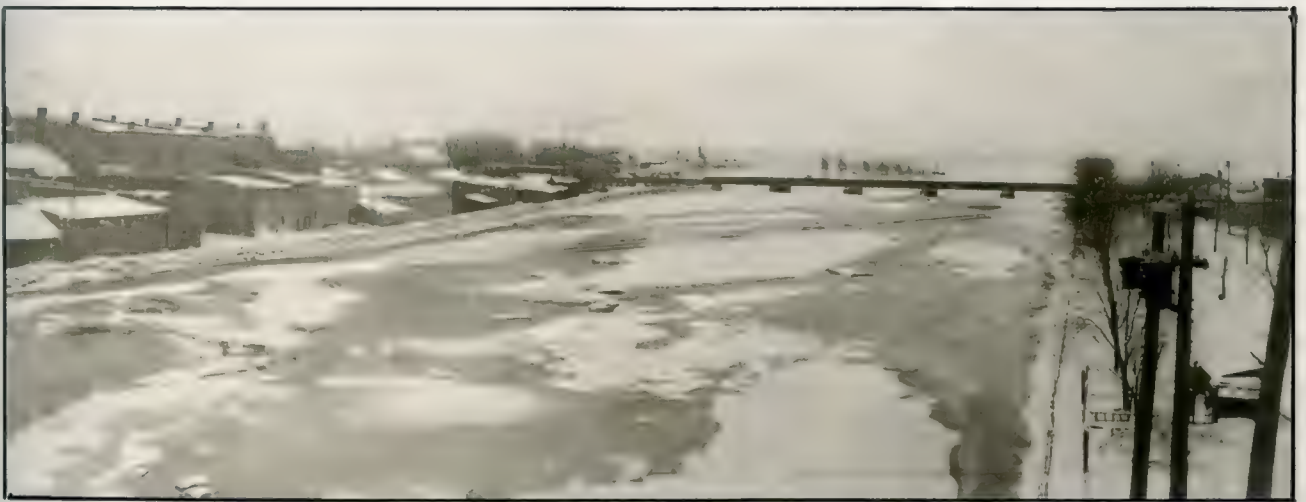
Photograph No. 8.

View of River, South of the Lower Bridge,  
Looking South from McLaughlin Garage.

During Thursday, Friday and Saturday, March 18th, 19th and 20th, there were only minor changes in the situation. The river opened up very considerably in the neighbourhood of the Foot Bridge, and the ice between the Lower Bridge and the Railway Bridge broke up in many places, as shown in photographs Nos. 8 and 9 on page 18, permitting a quantity of water to flow over the surface. The flow of the river steadily increased until by Saturday, March 20th, it averaged 2,300 cubic feet per second.

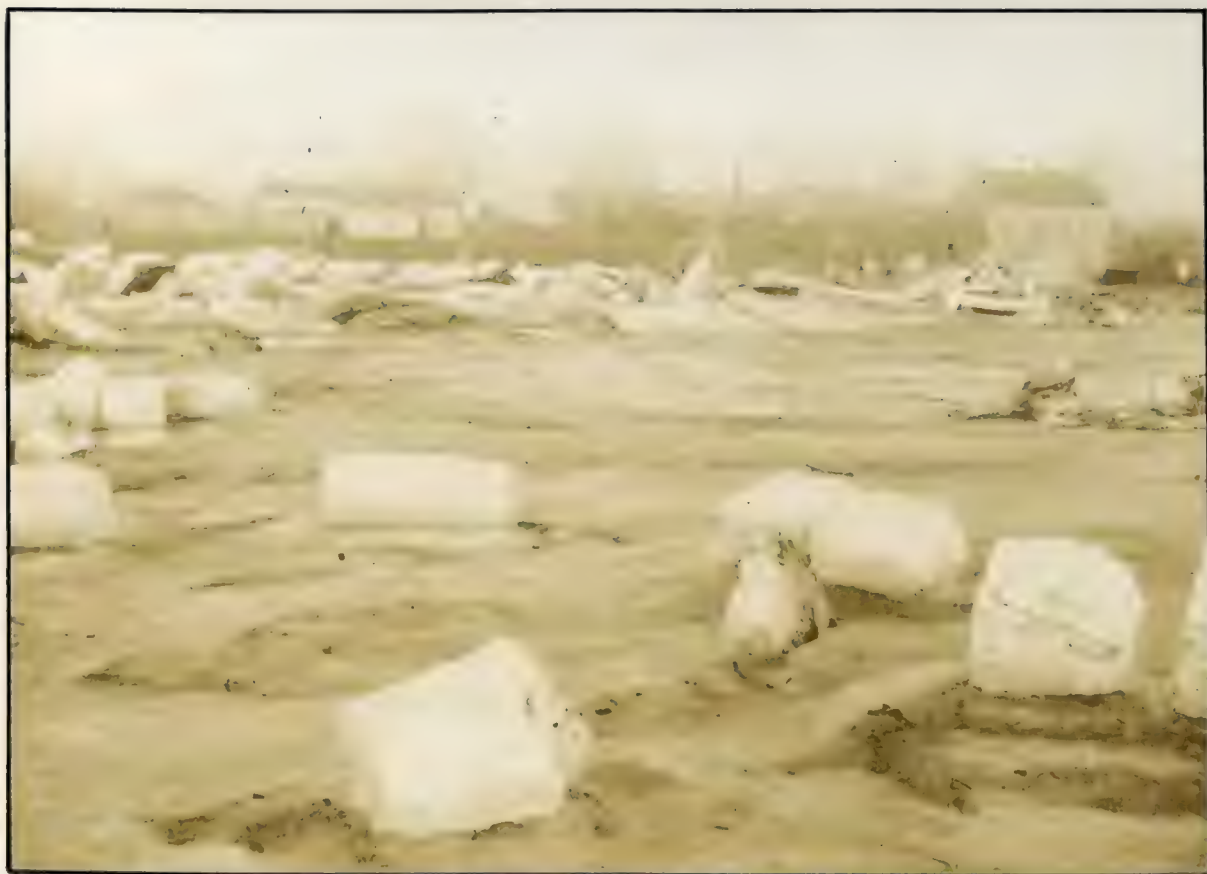
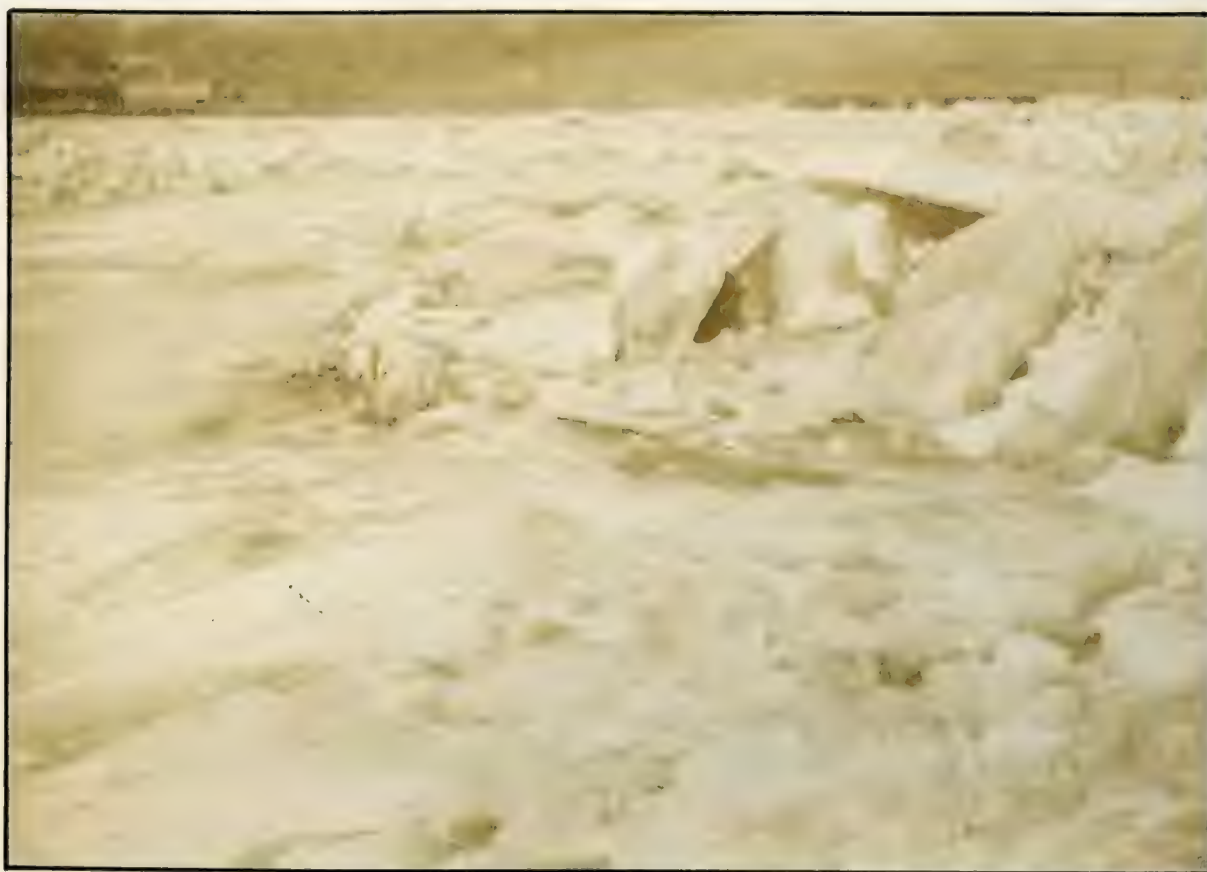
Front End of Jam, Looking West.

It was particularly noticeable that the front of the shove had buckled and broken the bay ice, and that the latter was the cause of the stoppage of the movement.

↑ Photographs Nos. 10 and 11 on page 23, showing the extreme south end of the jam, illustrate the manner in which the river ice attempted to make its way through the bay ice. The upstream side of the railway bridge is shown in photographs Nos. 12 and 13 on page 25, while the downstream side is shown in photographs Nos. 14 and 15 on page 26. In the background of photograph No. 14 the line of the east side of the front of the jam can be distinctly seen with the extreme front at the right-hand side of the picture. In photograph No. 15 it will be noticed that the east side of the jam was piled up against and even attempted to pass over the dyke leading to Victoria Park.

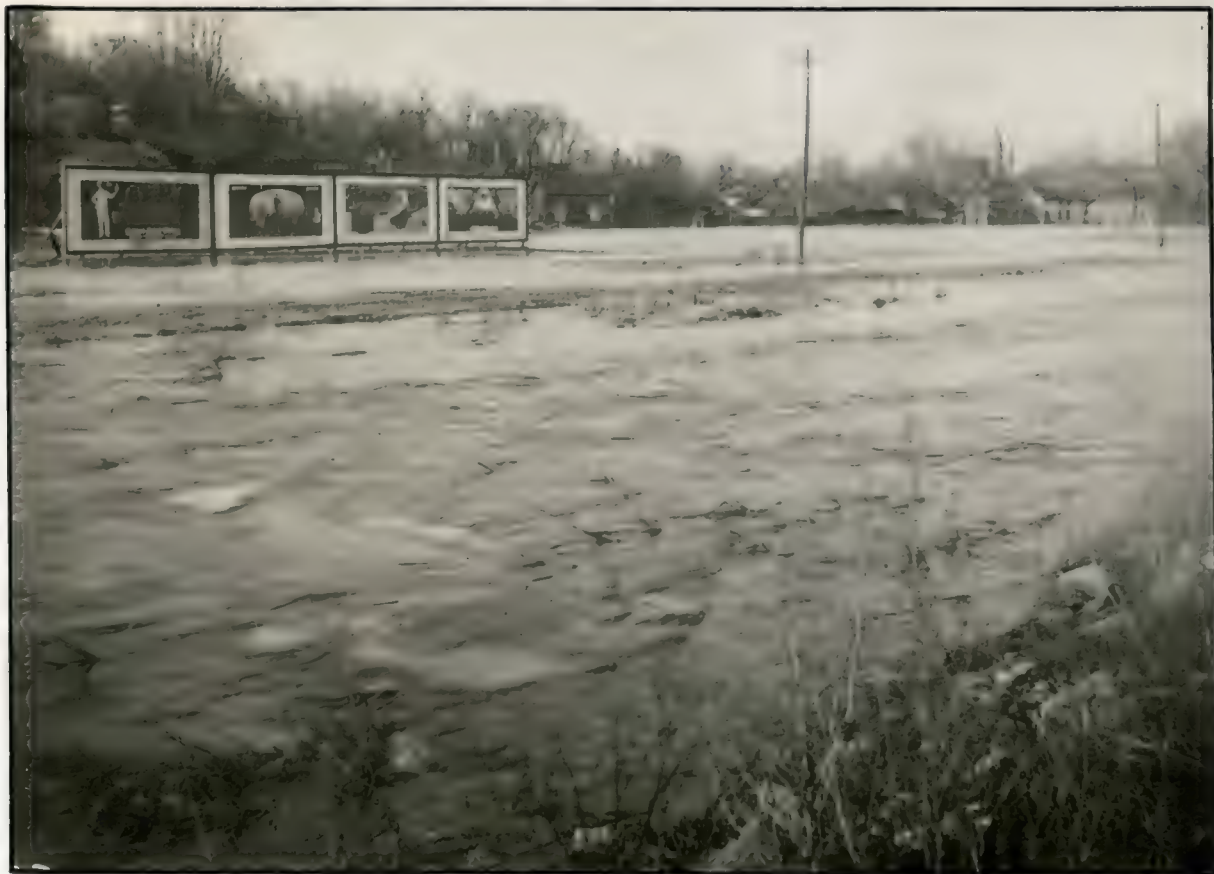
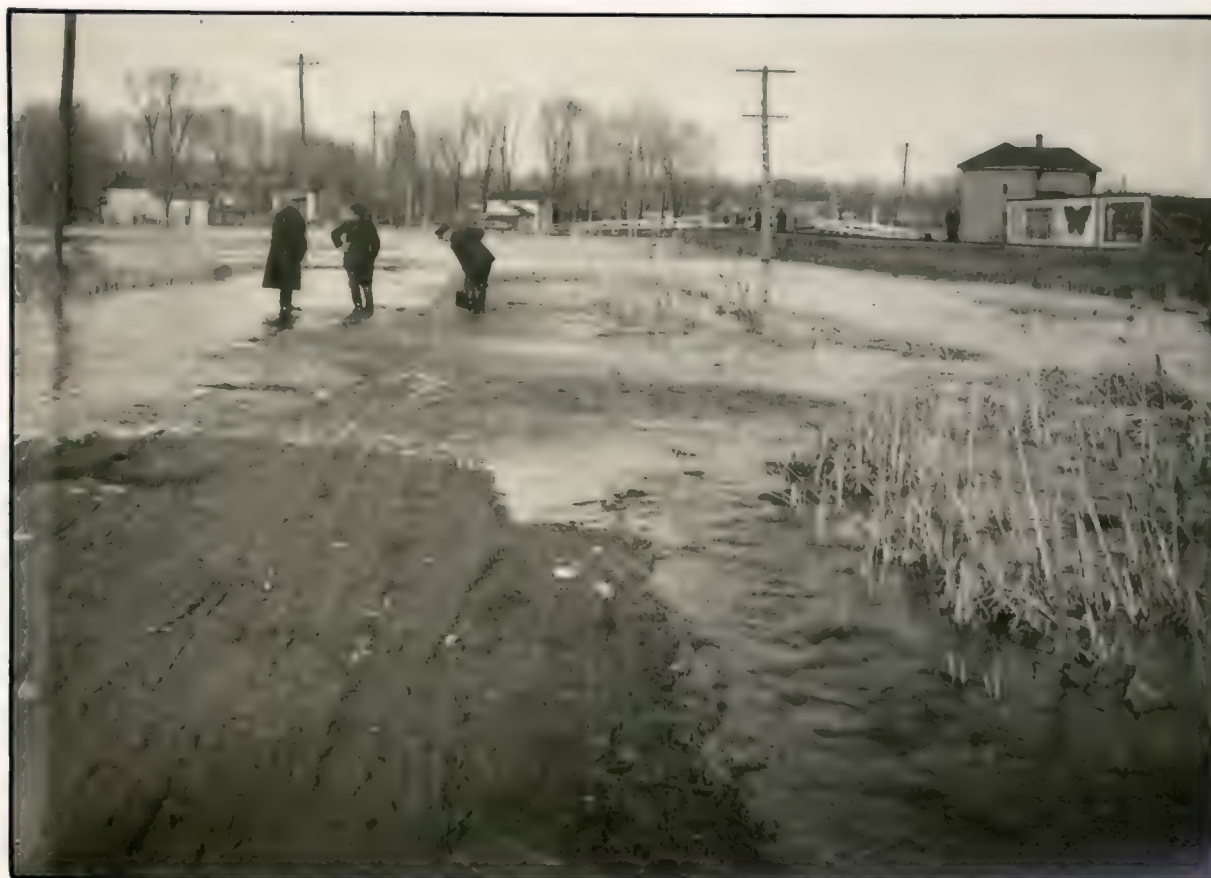
West End of Dundas Street,  
Looking East from West End.

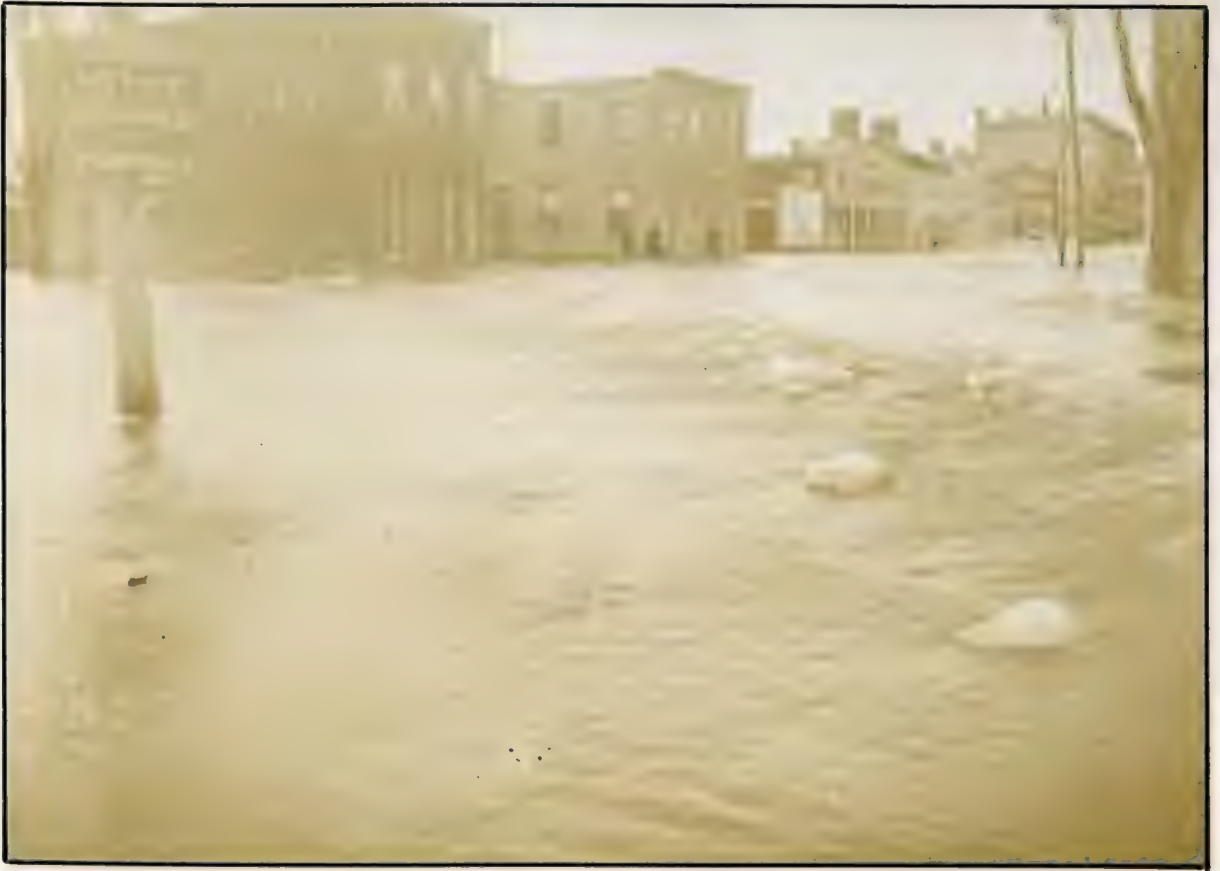
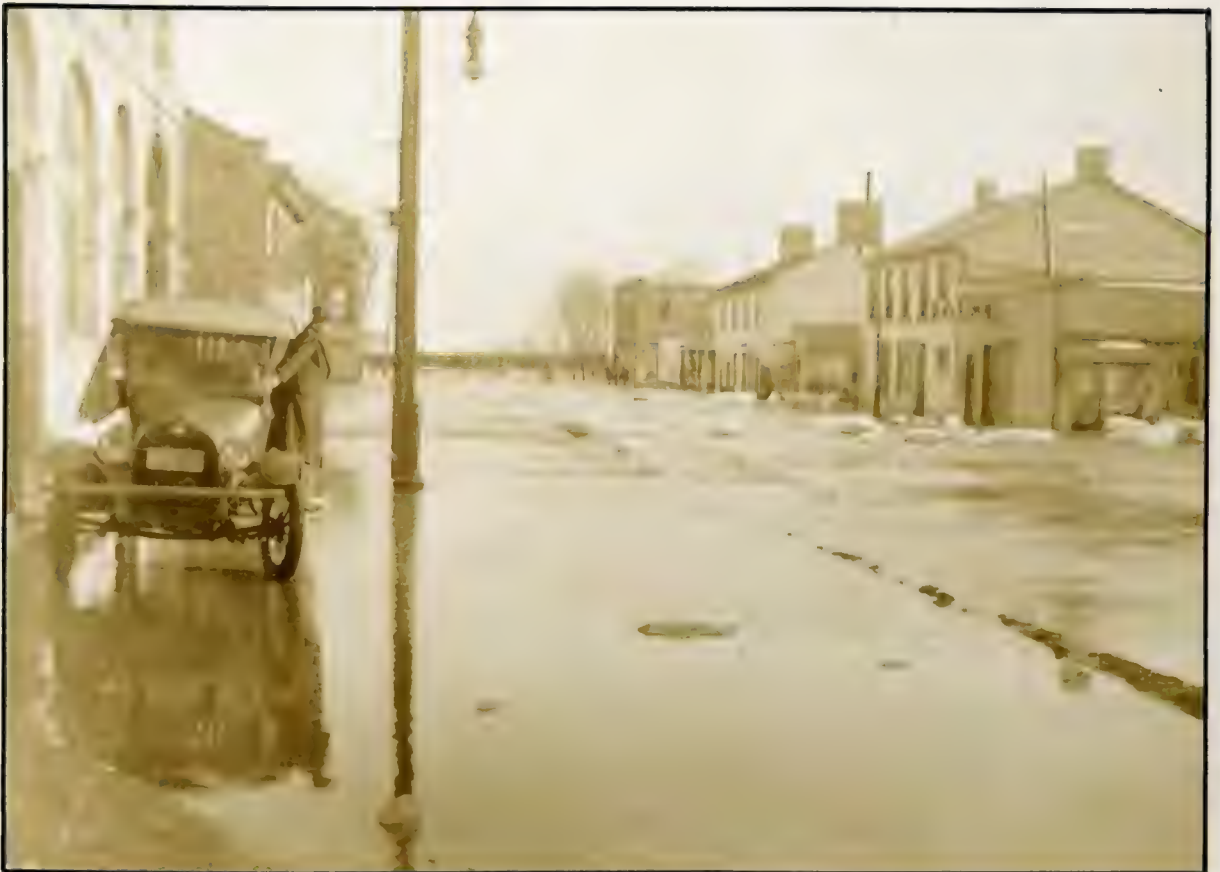
On the east side of the river the water overflowed the levee at a point a little south of the City Hall, and thence passed over Front Street reaching nearly to Pinnacle Street. Flowing down Front Street the water again reached the river through the subway leading to Victoria Park and down the steps leading to the boat-landing as shown by the arrows on the plan included as page 21. The water reached a maximum elevation of 253.8 at the northerly end of this area and 252.9 in the neighbourhood of Dundas Street, corresponding to a maximum depth of about 6 inches throughout. The condition at the south end of Front Street is shown in photograph No. 20 and a general view looking south along Front Street is shown in photograph No. 21, both on page 31. Both of these views were taken during the afternoon of March 21st.

Looking South from below City Hall.

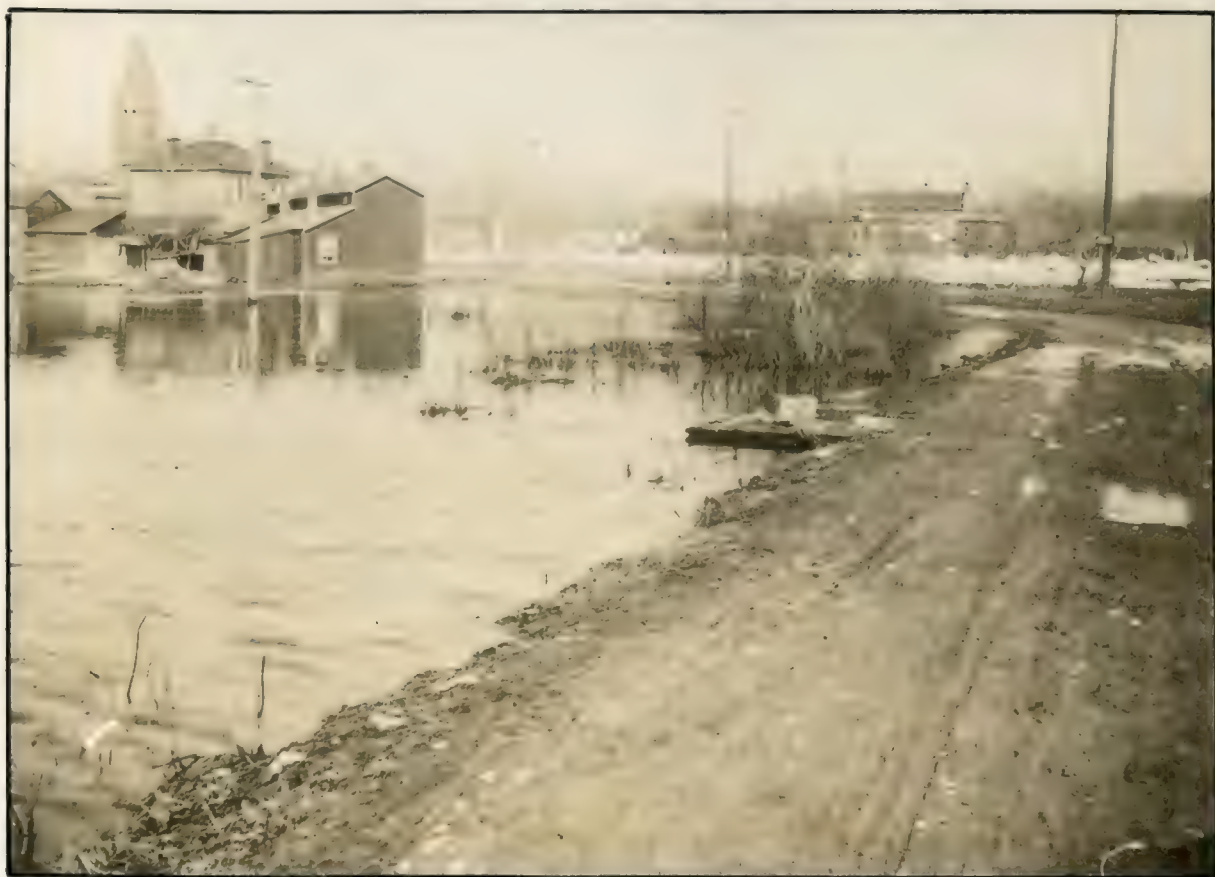
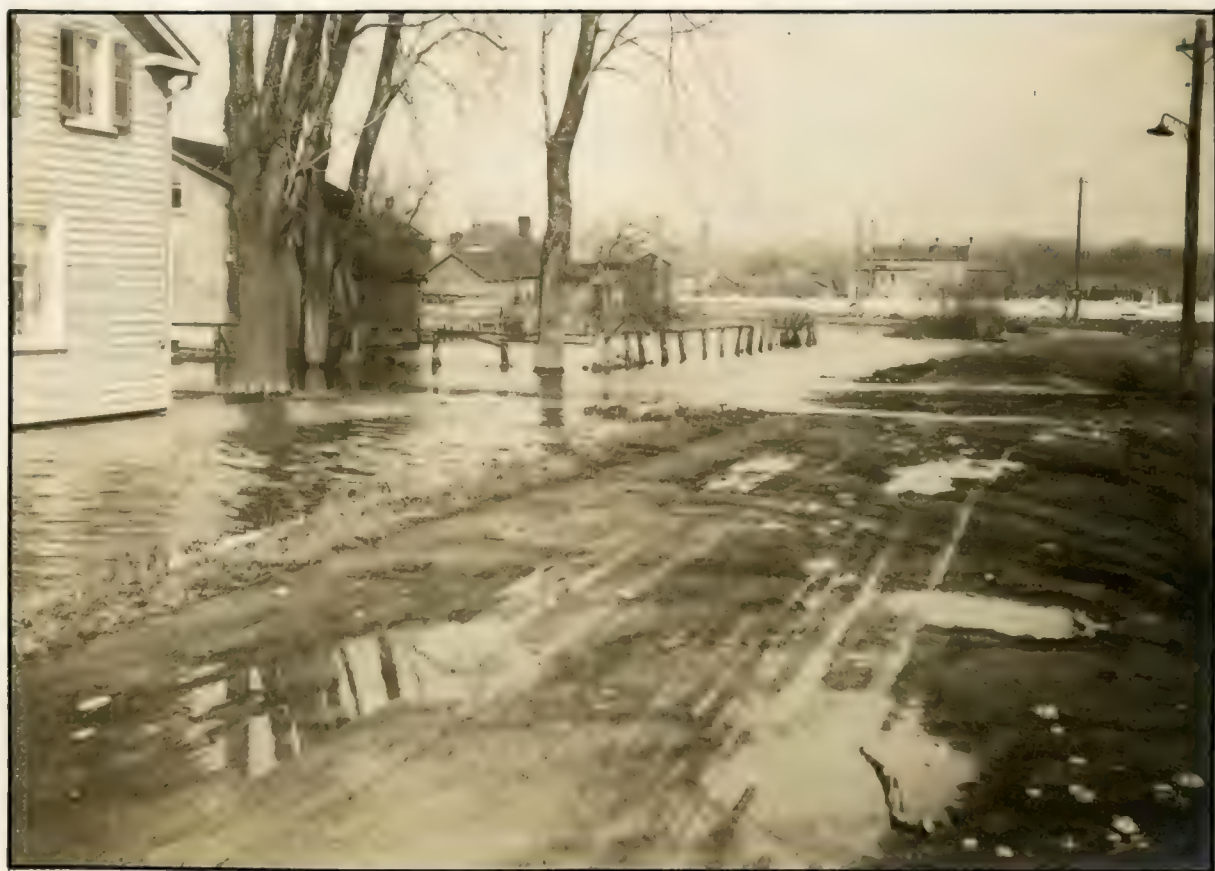
On this same date, namely, March 22nd, the water in the flooded area on the west side of the river, south of Bridge Street, receded considerably and no longer flowed over Dundas Street. The general condition in the neighbourhood of James, Dundas and Water Streets is shown in photographs Nos. 24 and 25, included as page 34.

Looking East from Dundas Street.
